# A Guide for Analyzing the Muon Monitor Signals

(not comprehensive)

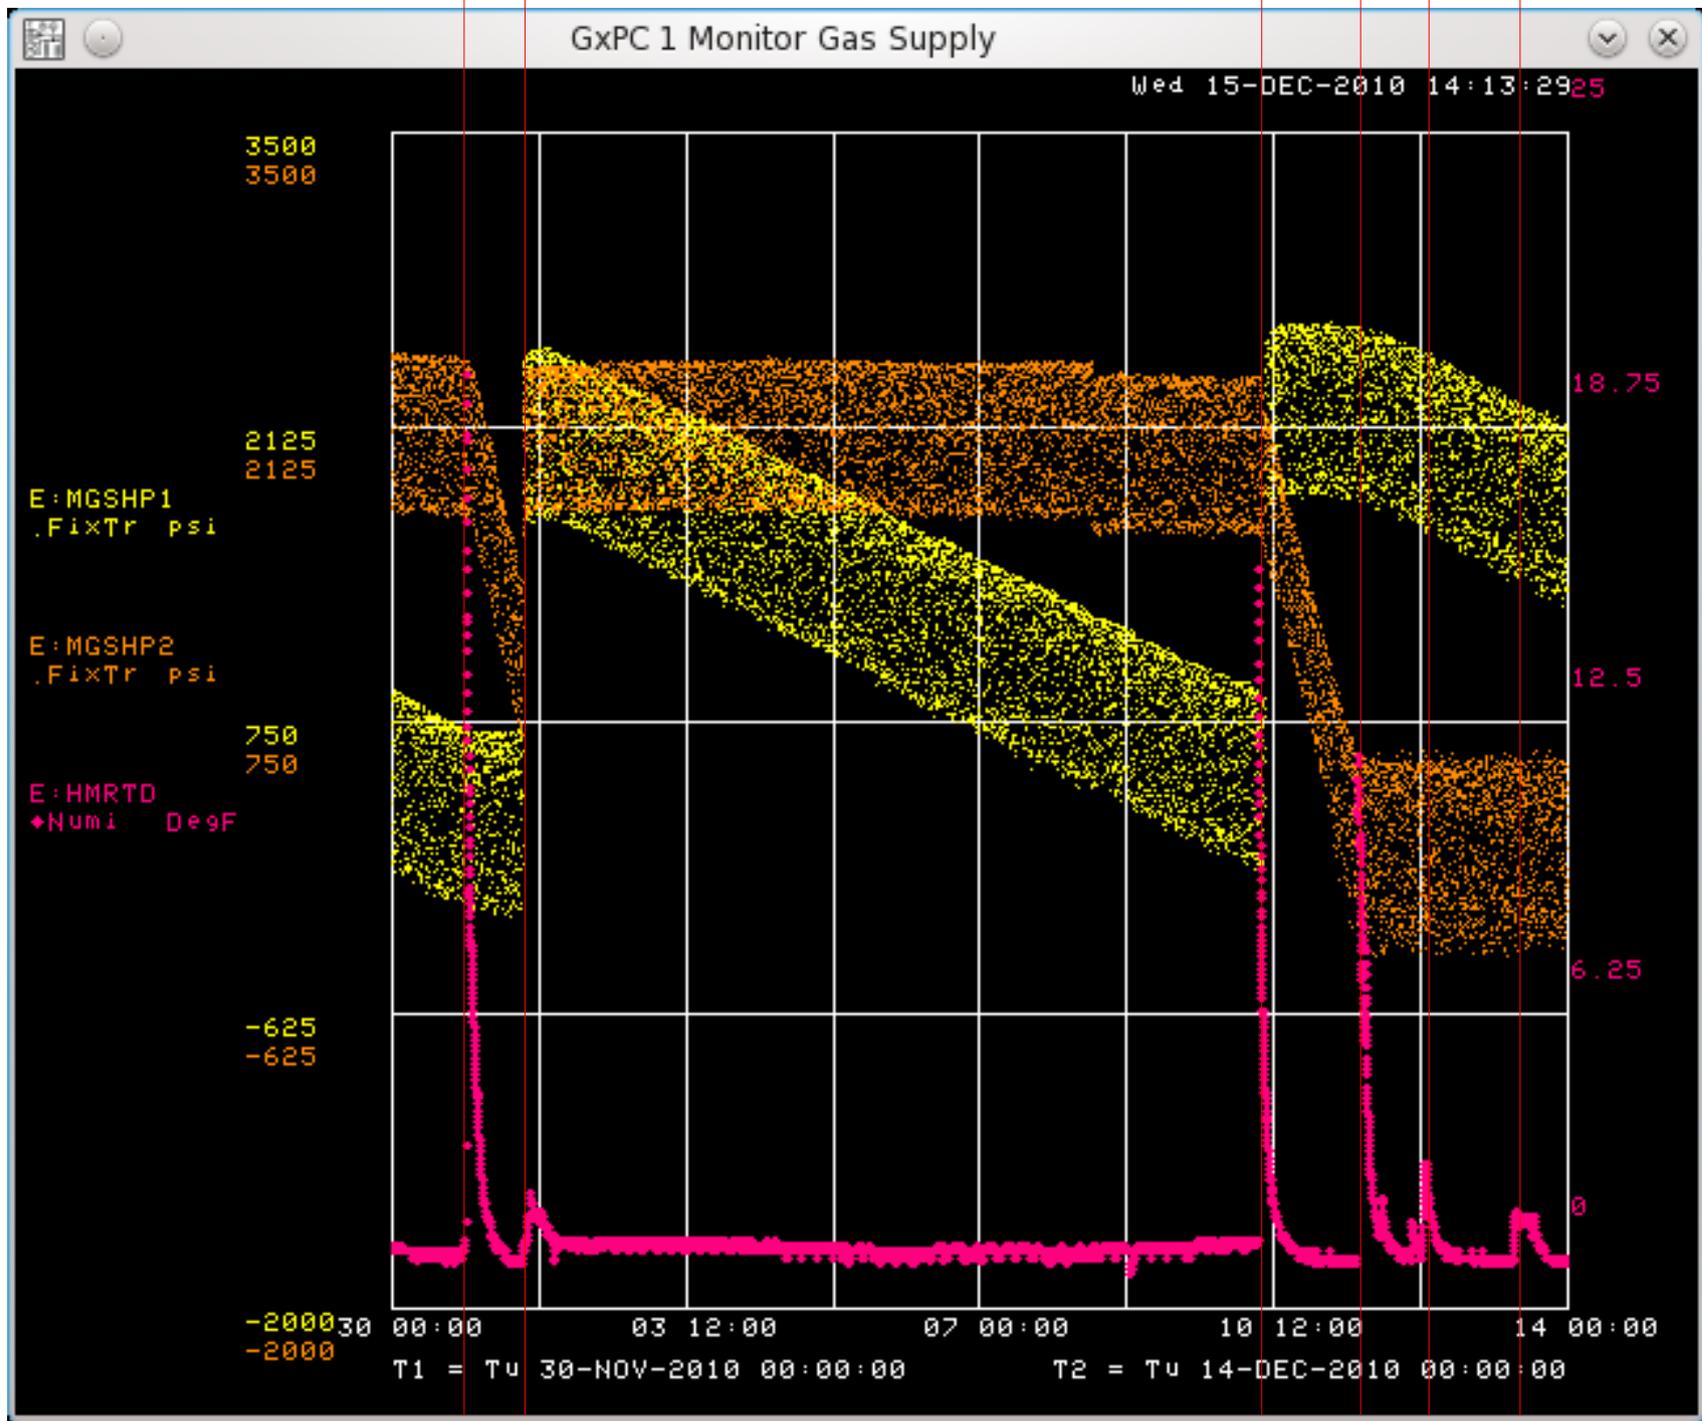
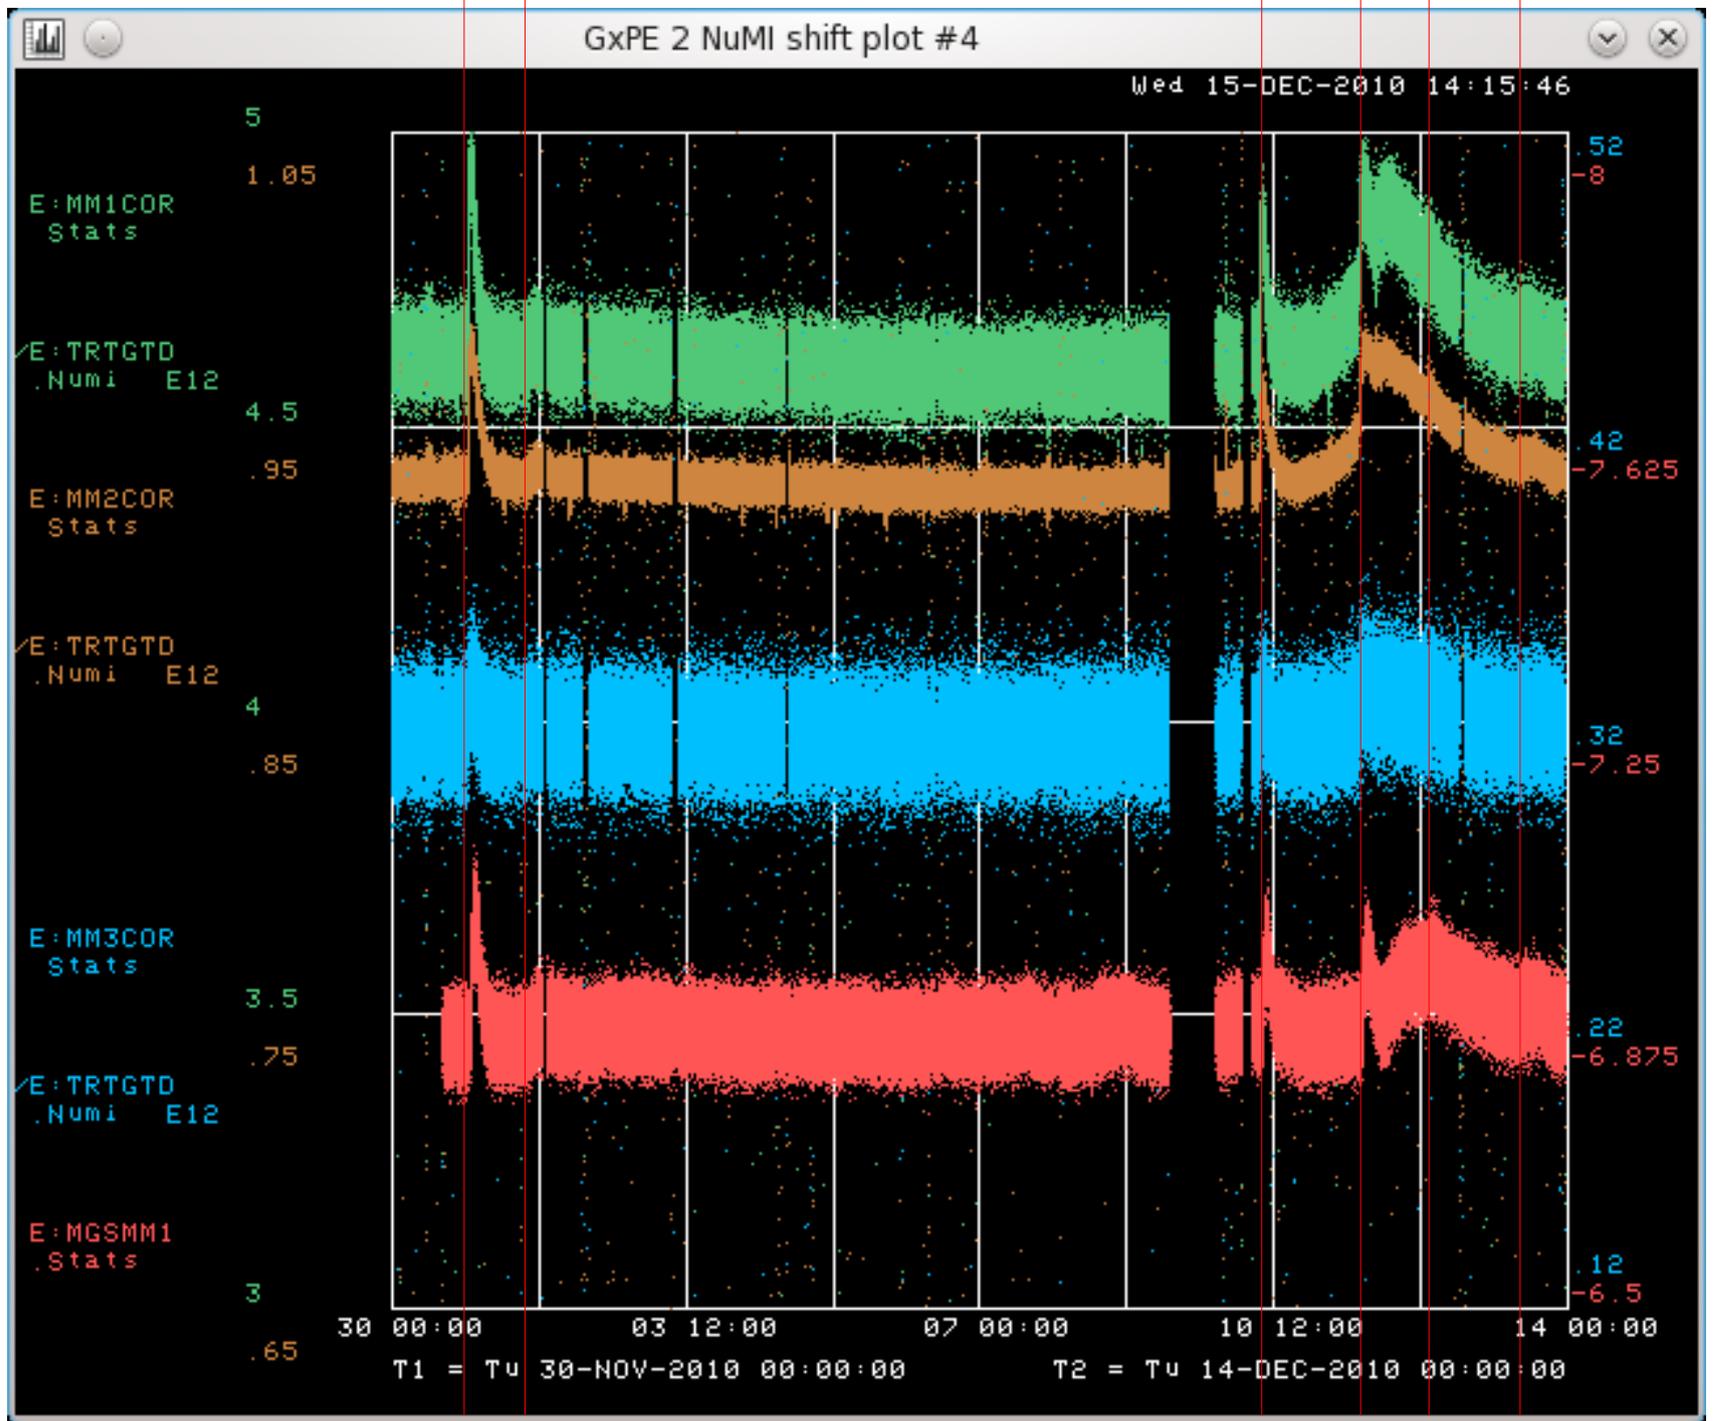
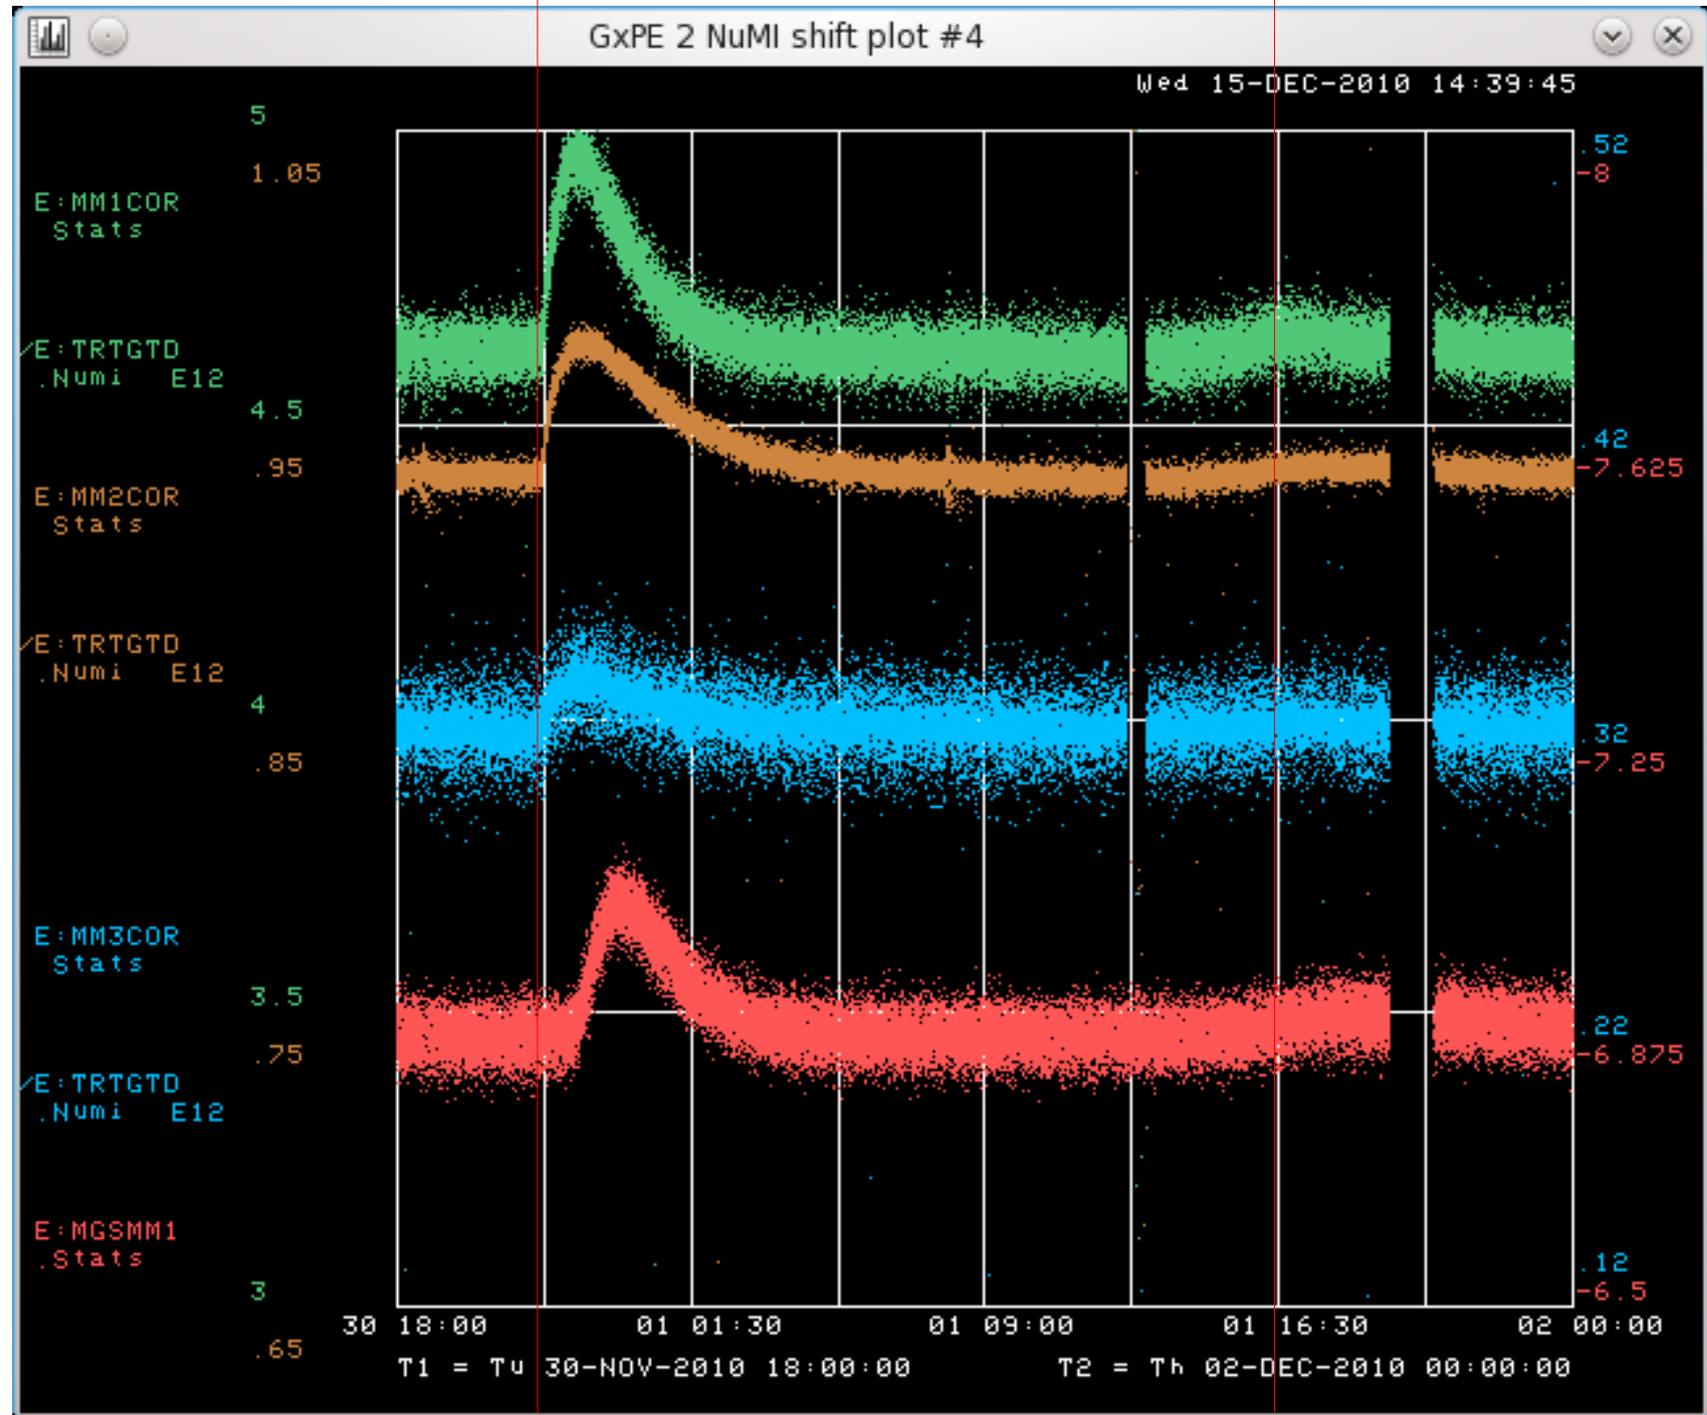
- Line 1: Prior to line 1 the system is drawing from the 8-bottle pack (indicated by E:MGSHP1 (yellow)). At line 1 the system automatically switches from drawing from the 8-pack (which is now empty) to drawing from the spare bottle (E:MGSPH2 (orange)). As is typical when a bottle exchange/automatic switch occurs there is gas contamination indicated by the jump in the Oxygen monitor (E:HMRTD) at the same time. The Muon Monitor signals and the Gas calibration monitor signal also jumps in response to the increase in O<sub>2</sub> level within the gas. Note that there is a short (~1/2 hour) delay in the jump in the muon monitor signals compared to the gas calibration chamber signal due to the fact that the gas calibration chamber is in the exhaust gas line of muon monitor 1, several hundred feet from from the mm1 itself. The signals start to decrease within a few hours as the contamination leaves the system.

- Line 2: All of the gas bottles are replaced with new, full, bottles. The system starts drawing from the 8-pack. The oxygen analyzer records a small jump in the impurity level. Upon very close inspection, the muon monitor signals also show a very small jump (most evident in mm1 signal) in response to the O<sub>2</sub> contamination but it is almost not noticeable.

- Line 3: The system switches from drawing from the 8-pack to the spare bottle. There is gas contamination indicated by the jump in the Oxygen monitor (E:HMRTD) at the same time. The Muon Monitor signals (not very noticeable in MM3 signal) and the Gas calibration monitor signal also jumps in response to the increase in O<sub>2</sub> level. Also at line 3 the bottles in the 8-pack are exchanged but the system remains. Drawing from the spare bottle until line 4.

- In between line 3 and line 4: There is a distinct “spike” from the O2 contamination. But after the spike (increase and quick decrease) the muon monitor signals seem to be slowly increasing, but without evidence to suggest a reason for this.

- Line 4: The system automatically switches to the 8-pack from the spare bottle. The O2 monitor jumps as do the Monitor signals indicating gas contamination. Shortly thereafter the signals start to decrease back down to “pre-contamination” levels.

- Lines 5 and 6: The O2 monitor spikes indicating a jump in O2 levels at these instances. The explanation is as follows: The 8 bottles are connected to a manifold that merges into a single gas line into the system. The bottles that are at a higher pressure prevent the lower pressure bottles from contributing gas to the manifold. Once the higher pressure bottles reach the same pressure as the lower pressure bottles then the lower pressure bottles will start contributing gas to the system. The spikes at lines 5 and 6 are most likely lower pressure bottles that start contributing gas to the system now that the pressure of the initially higher pressure bottles have decreased to the level of the lower pressure bottles.

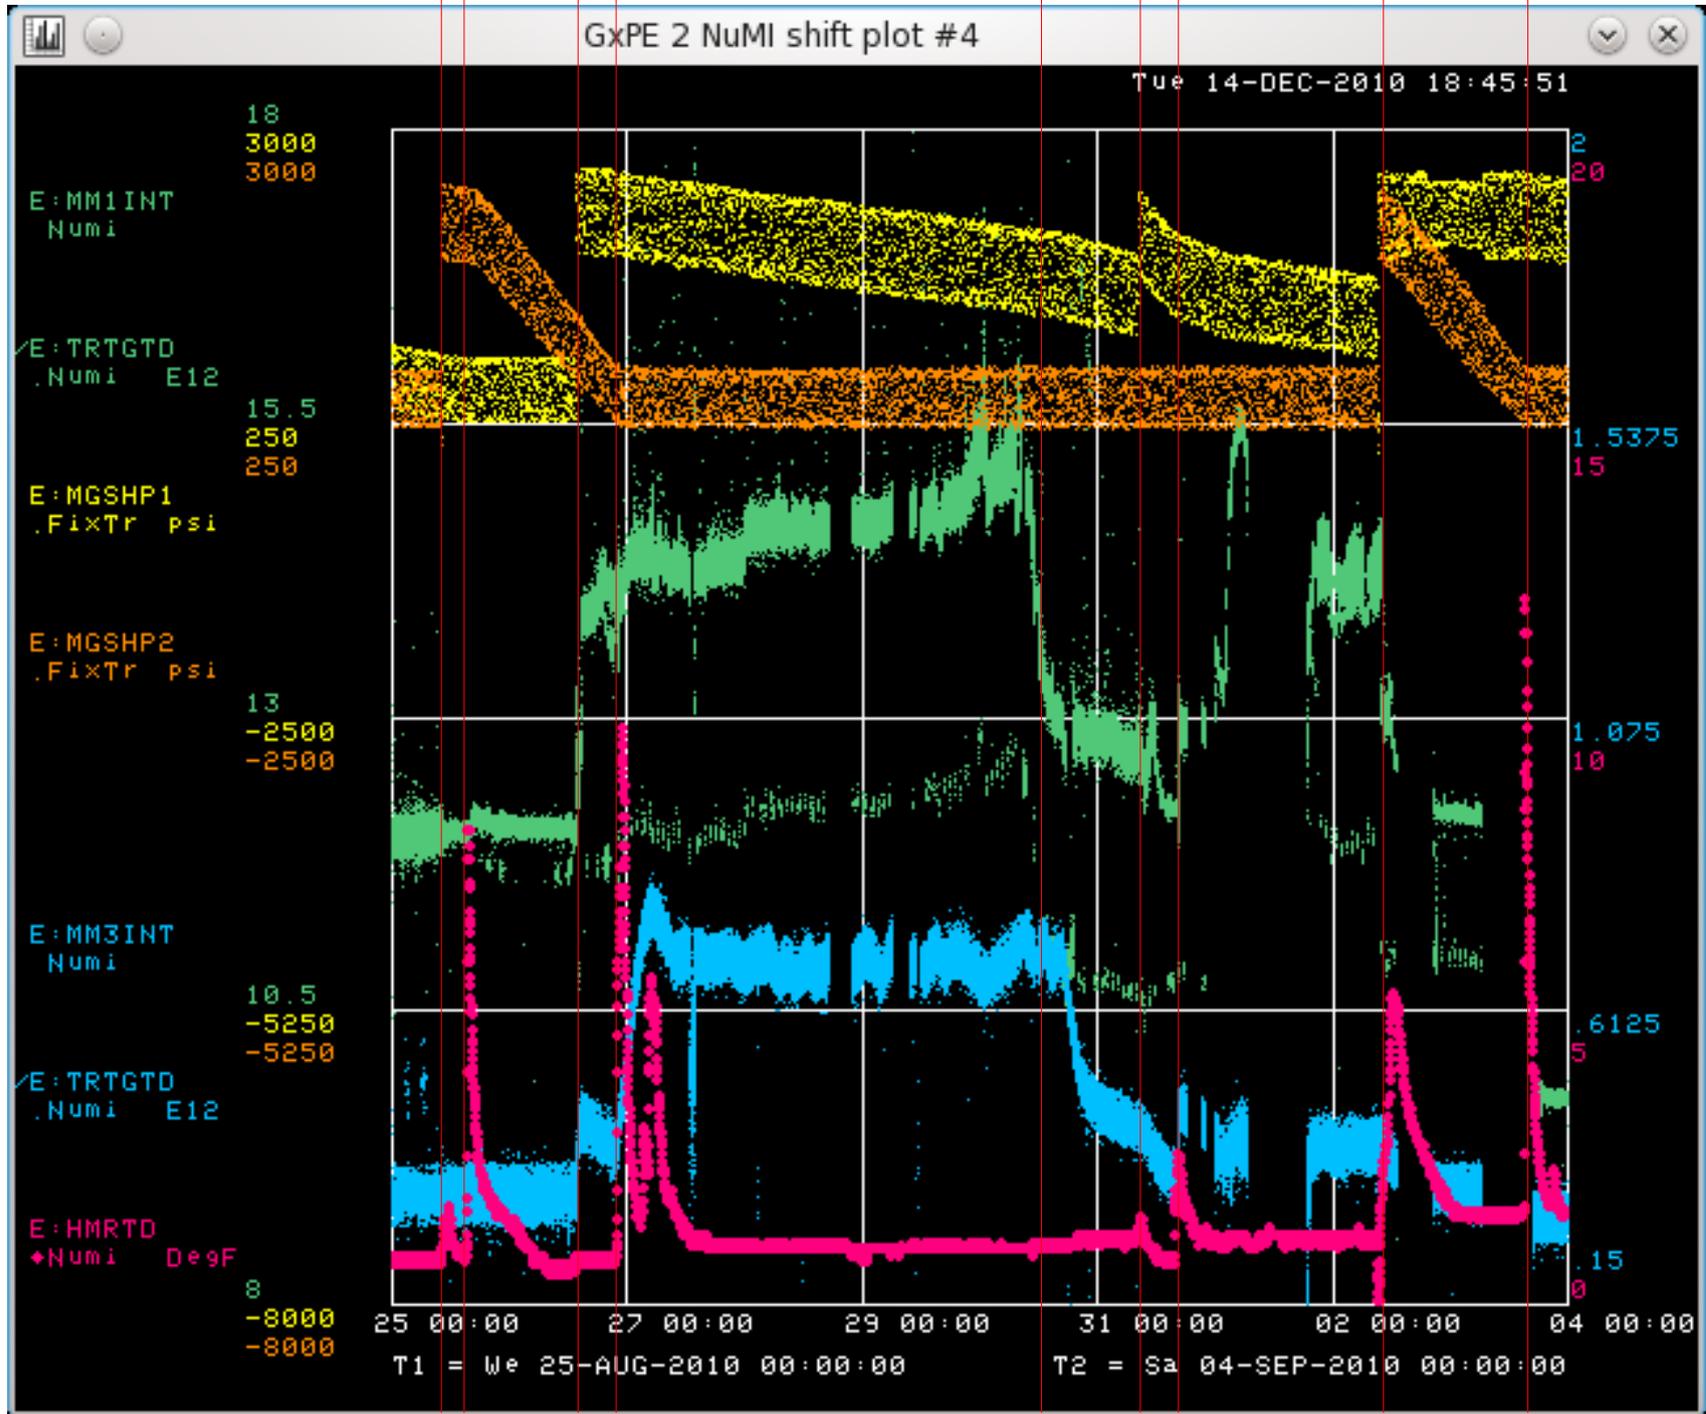
- Line 1: Both the spare bottle and the 8-pack are almost empty and require exchange. The Spare bottle only is exchanged. This is probably because there were not enough helium cylinders to replace all 8 bottles in the 8 pack. The system continues drawing from the 8-pack. The oxygen analyzer records a small jump in the impurity level

- Line 2: The system switches from drawing from the 8 pack to the spare bottle. The oxygen analyzer records a small jump in the impurity level. The muon monitor signals also shown a jump in response to the O2 contamination but on the scale of the plot it is not noticeable.

- Line 3: The 8-pack is replaced, but the system is still drawing from the spare bottle as is evident from the continued drop in the E:MGSHP2 reading after line 3. However at this same time the monitor signals experience a large jump. This jump is consistent with (looks like) gas contamination but the O2 monitor does not indicate O2 contamination. However the O2 monitor will only respond to O2 levels not other gases like Nitrogen, which is the largest component of Air.

- Line 4: The system switches from drawing from the spare bottle to the 8-pack. A large jump in the O2 impurity level is recorded by the O2 monitor. Muon monitor 3 signal experiences a very large jump. A short time later the O2 monitor records a few other jumps in the O2 level probably because at those instances other bottles within the 8-pack a starting to contribute to the system\*. From my experience, three things indicate that this is not just a case of O2 contamination:

1. The size of the jump in the signals (~70% jump in MM3).
2. The severe non-linearity in MM1 signal.
3. The signals do not begin to drop within a few hours.

Subsequent inspection of the gas cylinders showed that one of the bottles was Nitrogen not Helium.

- Line 5: The beam intensity drops. Because MM1 is experiencing severe non-linearity the signal drops significantly in response to the decrease in beam intensity. Shortly thereafter the Nitrogen bottle is valved off from the system. Thus the drop in MM3 signal a few hours later.

- Line 6: The Nitrogen bottle is replaced with helium. The signals drop faster.
- Line 7: There is a jump in the O<sub>2</sub> level and the monitor signals jump up and remain there. Most likely this is what happened: The new helium bottle was at the highest pressure of all of the bottles so between lines 6-7 it was supplying the system alone\*. At line 7 that bottle reaches the same pressure as the other 7 bottles and so all of the bottles start to contribute gas to the system. The fact that at this time the signal jumps up seems to suggest that there is some sort of contamination (another one of the bottles is nitrogen, or the purity of one of the helium bottles is not “high purity grade”) in one or more of the other 7 bottles. More than this, there is no definite explanation.

- Line 9: The spare bottle is used up and the system automatically switches to the 8-pack. The O<sub>2</sub> monitor jumps. Unfortunately at the exact instant this happens the beam is off. When the beam returns the beam is now in LE100z-200i, prior to line 9 it was in LE100z-200i. The muon monitor signals are changed due to the change in beam configuration so after line 9 cannot be compared to before line 9. Now one can only monitor the signals to make sure that they are stable (i.e. Flat, no jumps). For the time after line 9 (not shown), the signals are stable indicating the gas problem has been remedied.

- Line 8: Due to the fact that the signals are still not back to “normal”, I schedule a gas bottle exchange of all of the bottles in the system. This occurs at line 8. The system starts drawing from the newly replaced spare bottle.
